# VISUAL SNAGGING INSPECTION REPORT

| REPORT | Issued 4 September 2026 | REFERENCE | SS-20260903-26EF Version 1.0 |

## PURPOSE AND HEADLINE FINDINGS

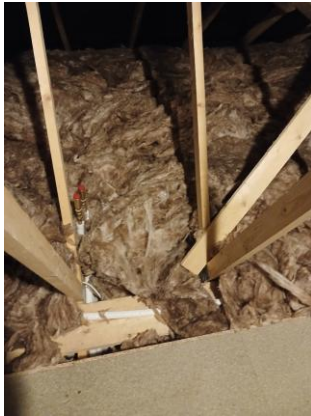
| Ref | Location | Element | Observation | Recommended next step | Priority | Photo ref |
|---|---|---|---|---|---|---|
| 01 | Roof space | Quilt insulation | Local areas of quilt insulation over the ceiling were uneven and appeared disturbed, leaving inconsistent coverage. No opening-up was undertaken and the reason for the disturbance was not established. | Re-lay the quilt insulation to provide continuous, even coverage without avoidable gaps or compression. Keep ventilation paths clear and coordinate around services. | P3 | 01A–01B |

**Photo 01A** Roof space — disturbed and uneven quilt insulation coverage.  
20260903\_081917.jpg

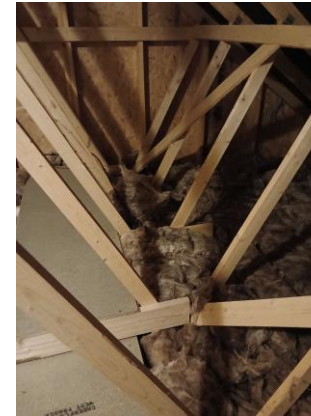
**Photo 01B** Roof space — detail of quilt insulation displaced around services.  
20260903\_081931.jpg

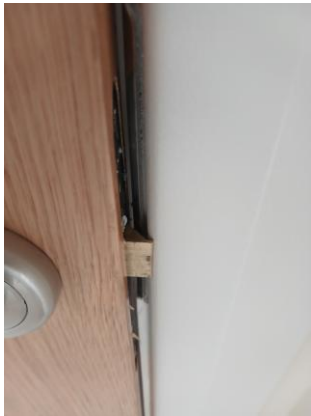
| Ref | Location | Element | Observation | Recommended next step | Priority | Photo ref |
|---|---|---|---|---|---|---|
| 02 | Upper floor – rear right bedroom | Door architrave / latch | The architrave margin was too tight for the latch tongue to pass freely; the latch contacted the architrave before reaching the strike plate. | Refit or adjust the architrave and door-set margins so the latch clears the trim and engages the strike plate without binding. Make good disturbed finishes. | P3 | 02 |

**Photo 02** Rear right bedroom — latch contacting tight architrave margin.  
20260903\_082200.jpg

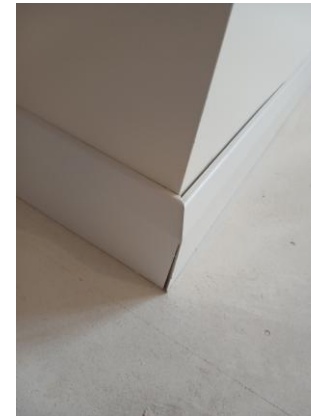
| Ref | Location | Element | Observation | Recommended next step | Priority | Photo ref |
|---|---|---|---|---|---|---|
| 03 | Upper floor – general | Skirtings | Sections of skirting had been cut to length but were not fixed at the time of inspection. Flooring installation appeared to remain outstanding in those areas. | Complete the flooring interface, securely fix the skirtings, make good joints and agree responsibility for final paint touch-ups before handover. | P3 | 03 |

**Photo 03** Upper floor — skirting section cut but not fixed.  
20260903\_082212.jpg

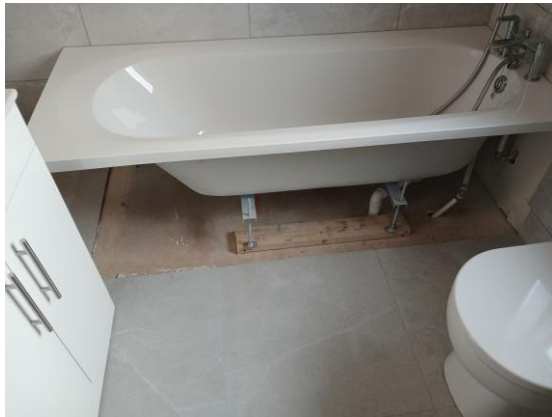
| Ref | Location | Element | Observation | Recommended next step | Priority | Photo ref |
|---|---|---|---|---|---|---|
| 04 | Main bathroom – rear | Bath panel / closure | The side closure below the bath was absent. The associated end detail should also be checked and completed where applicable. | Supply and securely fit the correct bath panel/closures, maintaining access to serviceable fittings where required, then complete adjoining finishes neatly. | P3 | 04 |

**Photo 04** Main bathroom — bath side closure/panel absent.  
20260903\_082234.jpg

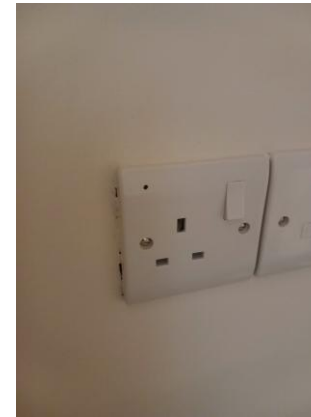
| Ref | Location | Element | Observation | Recommended next step | Priority | Photo ref |
|---|---|---|---|---|---|---|
| 05 | Drying cupboard | Socket surround | A small unfinished gap was visible immediately to the left of the socket faceplate. | Make good the local gap neatly with a compatible finishing material, without obstructing or contaminating the electrical accessory. | P4 | 05 |

**Photo 05** Drying cupboard — local unfinished gap beside socket faceplate.  
20260903\_082536.jpg

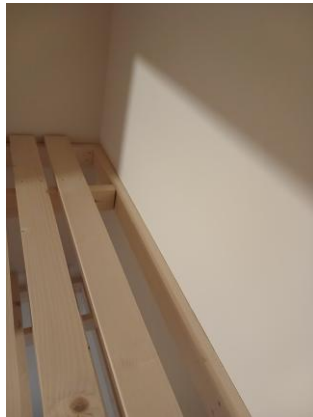
| Ref | Location | Element | Observation | Recommended next step | Priority | Photo ref |
|---|---|---|---|---|---|---|
| 06 | Drying cupboard | Shelving | The rear support/infill to the shelving was incomplete, leaving a gap at the back through which stored items could fall. | Complete the missing rear batten/infill and secure the shelving arrangement, then make good the finish. | P3 | 06 |

**Photo 06** Drying cupboard — incomplete rear shelf support/infill.  
20260903\_082604.jpg

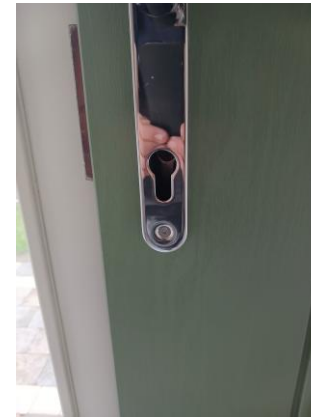
| Ref | Location | Element | Observation | Recommended next step | Priority | Photo ref |
|---|---|---|---|---|---|---|
| 07 | Entrance hall | Front door lock cylinder | The front entrance door did not have its permanent finished lock-cylinder arrangement in place at the time of inspection. | Install the intended permanent cylinder/lock furniture, verify smooth locking from both sides and confirm all final keys are controlled and issued at handover. | P2 | 07 |

**Photo 07** Entrance hall — permanent front-door cylinder arrangement incomplete.  
20260903\_082709.jpg

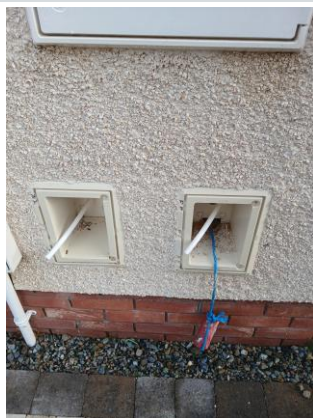
| Ref | Location | Element | Observation | Recommended next step | Priority | Photo ref |
|---|---|---|---|---|---|---|
| 08 | Front exterior | Service boxes | Two service boxes below the main meter/service enclosure were open and their external door covers were not fitted. | Fit the correct covers/doors, ensure they close securely and obtain confirmation from the relevant installer that the enclosures are complete before handover. | P2 | 08 |

**Photo 08** Front exterior — two service boxes without external covers.  
20260903\_082739.jpg

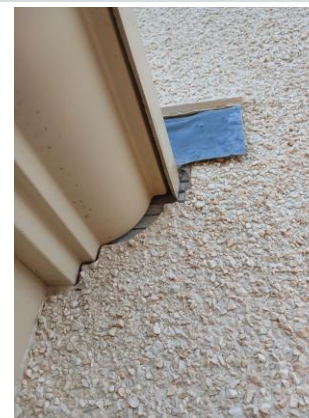
| Ref | Location | Element | Observation | Recommended next step | Priority | Photo ref |
|---|---|---|---|---|---|---|
| 09 | Front exterior | Canopy-to-render junctions | Gaps and exposed base finish were visible where both sides of the entrance canopy meet the rendered wall finish. | Complete the junctions with a suitable compatible external finishing/sealing detail and match the surrounding render as closely as practicable. | P3 | 09A–09B |

**Photo 09A** Front canopy — incomplete rendered junction at one side.  
20260903\_082817.jpg

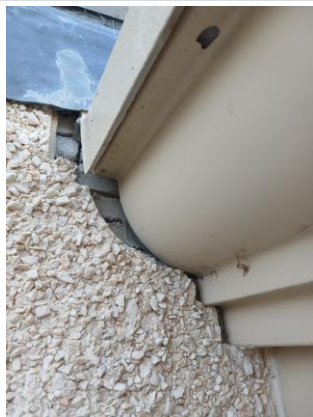
**Photo 09B** Front canopy — incomplete rendered junction at opposite side.  
20260903\_082824.jpg

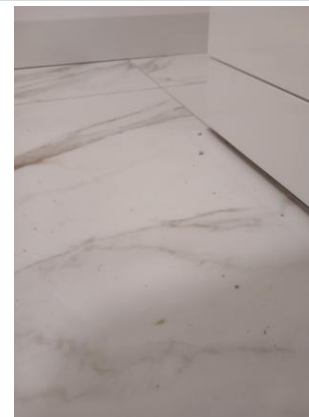
| Ref | Location | Element | Observation | Recommended next step | Priority | Photo ref |
|---|---|---|---|---|---|---|
| 10 | Ground floor – general | Final clean | Construction dust and debris remained on finished floor surfaces. | Carry out a full builders clean, including edges, frames, tracks and concealed collection points, before the final handover inspection. | P4 | 10 |

**Photo 10** Ground floor — construction debris remaining on finished floor.  
20260903\_082939.jpg

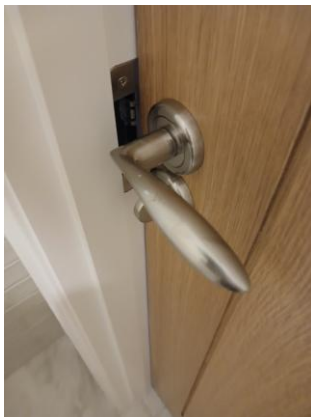
| Ref | Location | Element | Observation | Recommended next step | Priority | Photo ref |
|---|---|---|---|---|---|---|
| 11 | Ground floor bathroom | Door latch / strike | The latch and strike plate were misaligned. The latch did not engage when the door was pulled closed and the door could reopen. | Adjust the strike, latch and/or door alignment so the door closes freely and remains positively latched. | P3 | 11 |

**Photo 11** Ground-floor bathroom — door-latch engagement issue.  
20260903\_083122.jpg

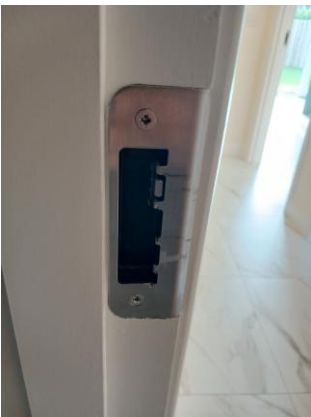
| Ref | Location | Element | Observation | Recommended next step | Priority | Photo ref |
|---|---|---|---|---|---|---|
| 12 | Kitchen / hall doorway | Door latch / strike | The latch and strike plate were misaligned. The latch did not engage when the door was pulled closed. | Adjust the strike, latch and/or door alignment so the door closes freely and remains positively latched. | P3 | 12 |

**Photo 12** Kitchen/hall door — strike/keep alignment detail.  
20260903\_083140.jpg

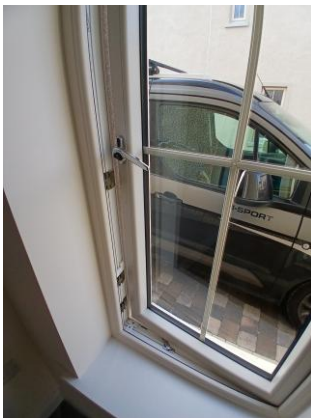
| Ref | Location | Element | Observation | Recommended next step | Priority | Photo ref |
|---|---|---|---|---|---|---|
| 13 | Front living room | Main window locking | The left-hand opening section could be opened while its handle was left in the locked position; the locking mechanism did not appear to engage. | Have the window installer adjust or repair the locking mechanism and verify secure engagement at all locking points before handover. | P2 | 13 |

**Photo 13** Front living room — main opening window did not lock securely.  
20260903\_083204.jpg

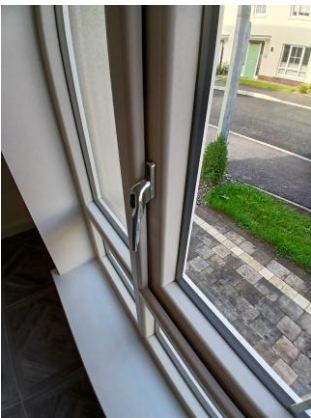
| Ref | Location | Element | Observation | Recommended next step | Priority | Photo ref |
|---|---|---|---|---|---|---|
| 14 | Front living room | Smaller window operation | The smaller window did not close and latch freely during operation; binding or misalignment was noted. | Adjust the hinges, sash alignment and locking hardware as required, then verify smooth opening, closing and positive latch engagement. | P3 | 14 |

**Photo 14** Front living room — smaller window operation/closure issue.  
20260903\_083324.jpg

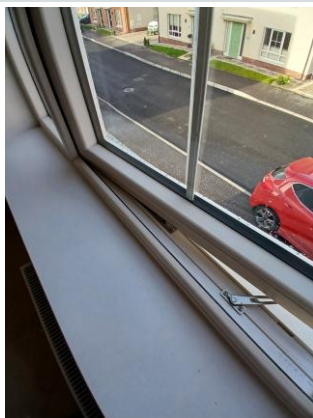
| Ref | Location | Element | Observation | Recommended next step | Priority | Photo ref |
|---|---|---|---|---|---|---|
| 15 | Upper floor – front left bedroom | Window operation | The opening section caught slightly during operation and did not move fully freely. | Adjust the sash, hinges and locking hardware as required, then verify smooth operation and positive closure. | P3 | 15 |

**Photo 15** Front left bedroom — opening window caught during operation.  
20260903\_083402.jpg

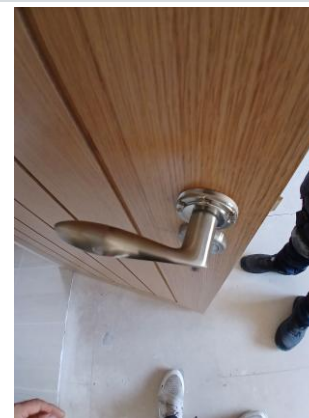
| Ref | Location | Element | Observation | Recommended next step | Priority | Photo ref |
|---|---|---|---|---|---|---|
| 16 | Main bedroom en-suite | Door handle | The door handle was loose and had excessive movement during normal operation. | Securely refit the handle and spindle or replace defective components, then verify reliable latch operation. | P3 | 16 |

**Photo 16** Main bedroom en-suite — loose door handle.  
20260903\_083500.jpg

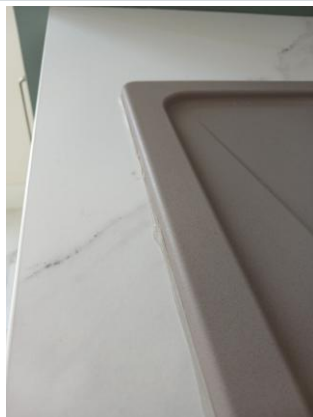
| Ref | Location | Element | Observation | Recommended next step | Priority | Photo ref |
|---|---|---|---|---|---|---|
| 17 | Kitchen | Sink perimeter sealant | Excess sealant had squeezed out around parts of the sink-to-worktop perimeter, leaving an uneven finish. | Carefully remove excess material and renew local sealant where necessary to provide a continuous, neat finish without damaging adjoining surfaces. | P4 | 17 |

**Photo 17** Kitchen — excess sealant at sink-to-worktop perimeter.  
20260903\_083738.jpg

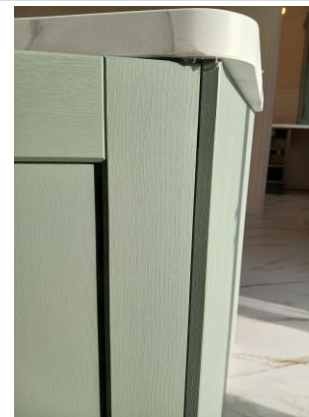
| Ref | Location | Element | Observation | Recommended next step | Priority | Photo ref |
|---|---|---|---|---|---|---|
| 19 | Kitchen island | Cabinet doors | The outer door in each of the two double-door sets contacted the adjacent gable/end panel and did not move freely. | Adjust hinges, door alignment and margins so all doors operate freely with consistent clearances and without rubbing the finished panels. | P3 | 18A–18B |

**Photo 18A** Kitchen island — outer cabinet door contacting gable/end panel.  
20260903\_084138.jpg

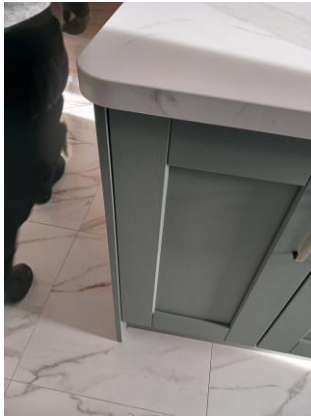
**Photo 18B** Kitchen island — second outer cabinet door with tight margin.  
20260903\_084145.jpg

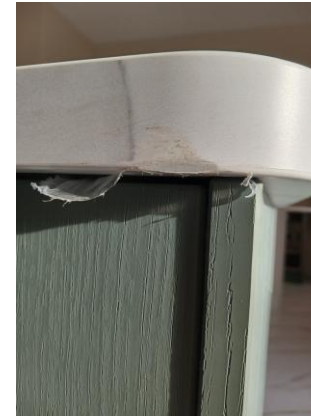
| Ref | Location | Element | Observation | Recommended next step | Priority | Photo ref |
|---|---|---|---|---|---|---|
| 20 | Kitchen island – rear-door end | Worktop finish | A conspicuous scratch/finish defect was visible on the underside/edge of the worktop near the corner of the island. | Assess the damaged area and carry out an appropriate manufacturer-approved repair or replacement to restore a consistent finish. | P3 | 19 |

**Photo 19** Kitchen island — damaged/scratched worktop finish near corner.  
20260903\_084110.jpg

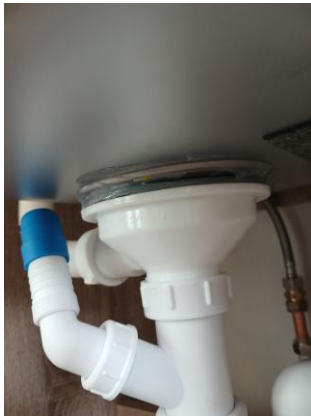
| Ref | Location | Element | Observation | Recommended next step | Priority | Photo ref |
|---|---|---|---|---|---|---|
| 21 | Utility room | Sink waste connection | Moisture was detected at the seal/junction between the sink waste fitting and the underside of the sink while the tap was operated. | Promptly inspect, refit or reseal the waste connection as required. Dry the area and repeat an operational check to confirm no further moisture is present. | P2 | 20 |

**Photo 20** Utility sink — waste outlet/seal junction where moisture was detected.  
20260903\_084227.jpg

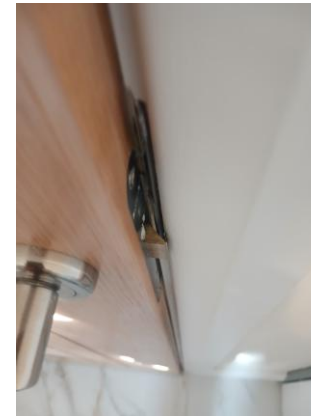
| Ref | Location | Element | Observation | Recommended next step | Priority | Photo ref |
|---|---|---|---|---|---|---|
| 22 | Under-stairs store | Door architrave / latch | The architrave margin was too tight for the latch tongue to pass freely; the latch contacted the trim before reaching the strike plate. | Refit or adjust the architrave and door-set margins so the latch clears the trim and engages correctly. Make good disturbed finishes. | P3 | 21A–21B |

**Photo 21A** Under-stairs store — latch obstructed by tight architrave margin.  
20260903\_084258.jpg

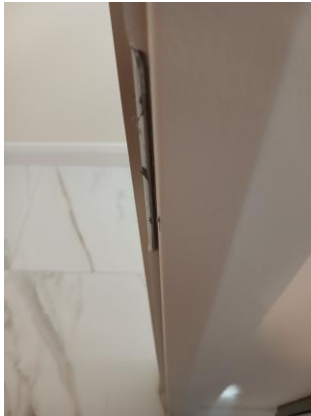
**Photo 21B** Under-stairs store — strike/architrave alignment detail.  
20260903\_084300.jpg

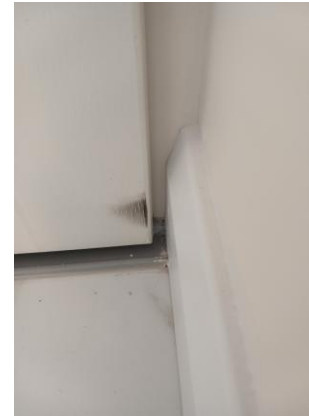
| Ref | Location | Element | Observation | Recommended next step | Priority | Photo ref |
|---|---|---|---|---|---|---|
| 23 | Utility external door | Door-leaf finish | A prominent black mark was present at the lower right-hand corner of the external face of the door. | Clean the mark using a finish-compatible method. If it remains, carry out an appropriate local repair or touch-up to the door finish. | P4 | 22 |

**Photo 22** Utility external door — black mark at lower right-hand corner.  
20260903\_084410.jpg

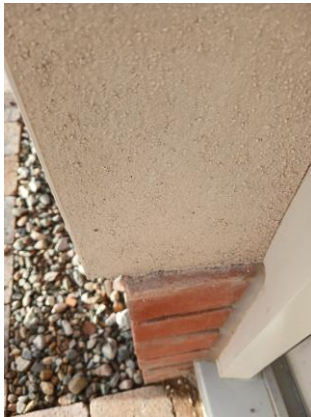
| Ref | Location | Element | Observation | Recommended next step | Priority | Photo ref |
|---|---|---|---|---|---|---|
| 24 | Rear exterior – utility door | Rendered corner / bead | At the right-hand side of the utility door, the rendered corner/bead detail stopped short and the finish appeared incomplete. | Complete and make good the corner detail using a compatible external render system, then blend the finish with the surrounding work. | P3 | 23 |

**Photo 23** Utility door exterior — incomplete render corner/junction.  
20260903\_084625.jpg

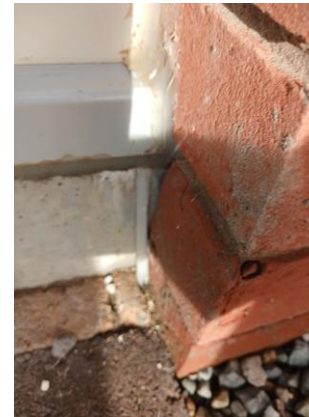
| Ref | Location | Element | Observation | Recommended next step | Priority | Photo ref |
|---|---|---|---|---|---|---|
| 25 | Rear exterior – utility door | Brick/render junction | At the left-hand side of the utility door, facing brickwork projected beyond the adjacent rendered edge, unlike the general set-back detail elsewhere. | Have the contractor review the junction against the intended façade detail and make good the transition to provide a consistent, weather-resisting finish. | P3 | 24 |

**Photo 24** Utility door exterior — inconsistent brick/render junction.  
20260903\_084525.jpg

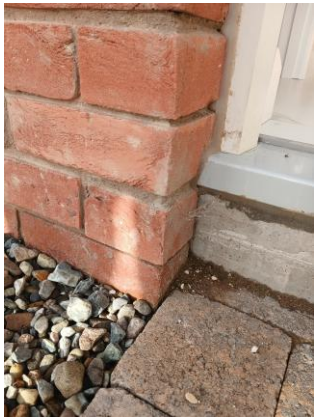
| Ref | Location | Element | Observation | Recommended next step | Priority | Photo ref |
|---|---|---|---|---|---|---|
| 26 | Rear exterior – utility door | Facing brickwork | The second brick above the base on the right-hand side projected beyond adjacent brickwork and the surrounding mortar margins were uneven. | Reset or make good the local brick and mortar work as appropriate, matching the alignment, joint profile and finish of the adjoining brickwork. | P3 | 25 |

**Photo 25** Utility door exterior — projecting brick and uneven mortar margins.  
20260903\_084634.jpg

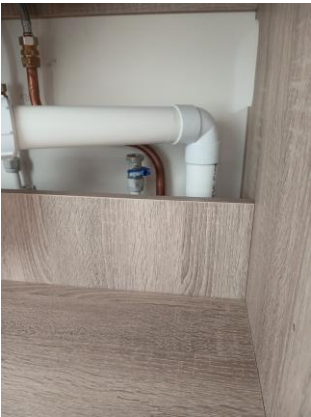
| Ref | Location | Element | Observation | Recommended next step | Priority | Photo ref |
|---|---|---|---|---|---|---|
| 29 | Utility room | Washing-machine services | A cold-water supply point and waste provision were present below the utility sink. No appliance was connected and the final appliance connection was not assessed. | If appliance installation forms part of the contract, confirm that the final connection, securing and operational checks are completed by the appropriate installer. | OBS | 29 |

**Photo 29** Utility room — washing-machine service points below sink.  
20260903\_084458.jpg
